Neighborhood Energy Connection Residential Energy Specification			Auditor: Michael Childs Phone: 651-221-4462 x145
Spec ID#	Spec Title	Specification	Location / Notes
304	Replace Water Heater with Power Vented .67 EF	Replace water heater with a power-vented water heater with an EF of .67. Include pressure & temperature release valve, discharge tube to within 6" of floor and PVC flue to power vent to exterior.	
310	Install Central Air Conditioning Unit	Install 16 SEER split system central air conditioning unit, following local building code. Using OEM performance information and industry-approved procedures, confirm that the selected equipment satisfies/meets the load requirements at the system design conditions.	
500	Seal Attic Bypasses	Contractor shall seal all attic bypasses. Bypasses shall be defined as any break in the envelope of a house between a heated living space and an unheated area or exterior. Bypass locations include, but are not limited to, the following areas: chimneys, soil stacks, end walls, dropped ceilings, open plumbing walls, beneath knee walls and around duct work, electrical work and attic access points. Bypasses shall be sealed in such a manner that the movem

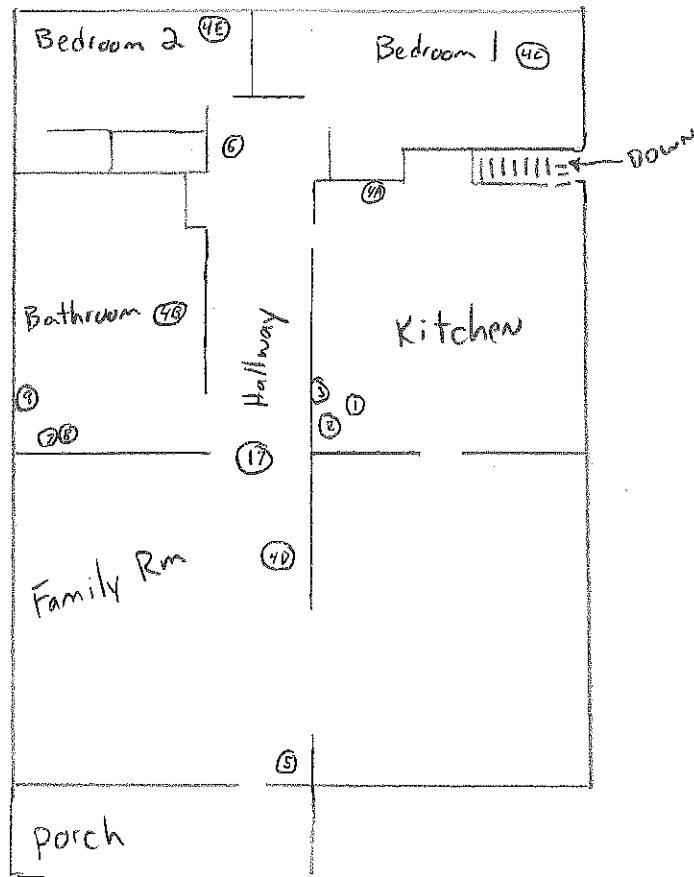
Asbestos
Sample
Locations

None of the materials sampled were found to contain asbestos.

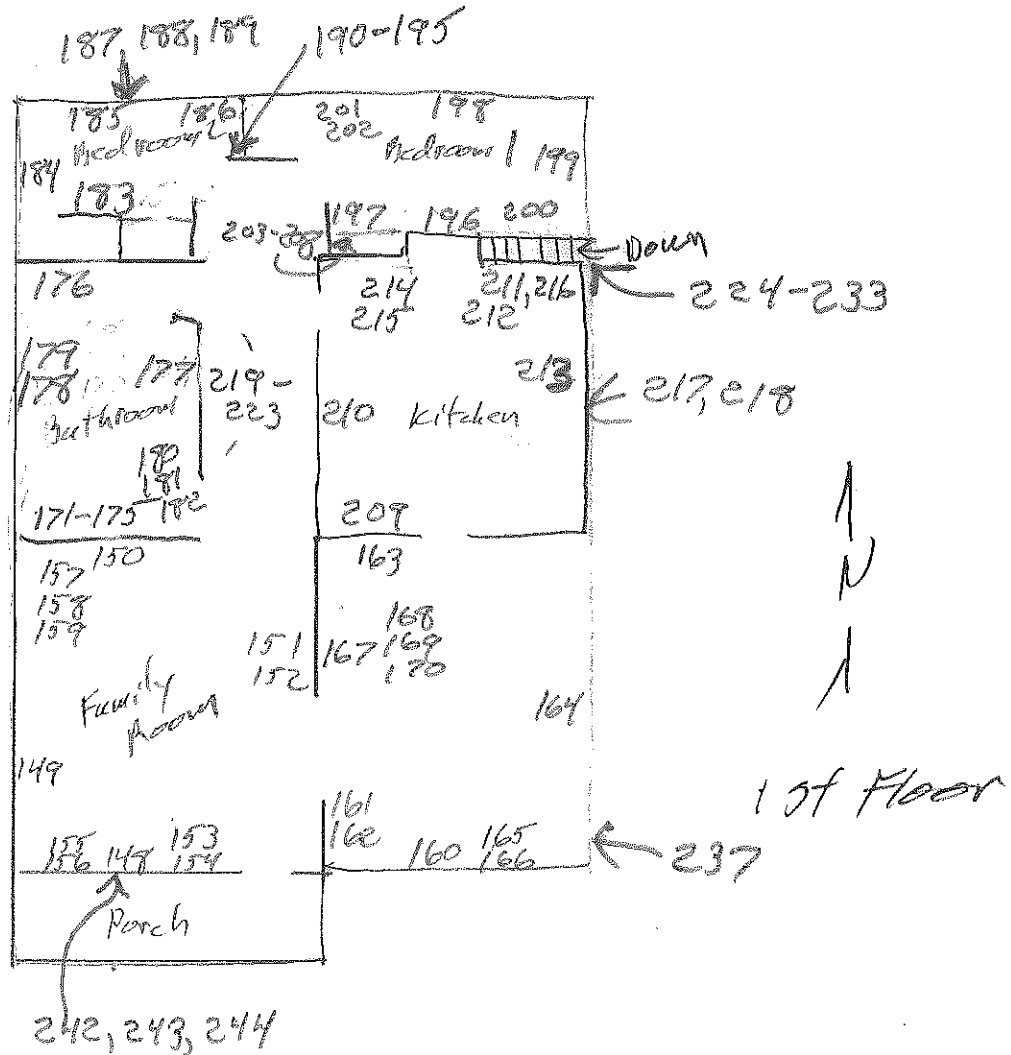
Lead
Sample
Location

Tested Building Component	Number of Test Locations	Positive Results	Negative Results	LBP Classification
Plaster Walls and Ceilings	48	18	30	Positive
Wood Porch	2	2	0	Positive
Wood Siding (house and garage)	2	1	1	Positive
Wood Windows (Exterior and Interior)	9	7	2	Positive
Wood Doors (Exterior and Interior)	12	4	8	Positive
Wood Crown Molding	1	0	1	Negative
Wood Baseboards	5	1	4	Positive
Wood Beams	3	0	3	Negative
Cabinets	2	0	2	Negative
Metal Radiator Covers	4	0	4	Negative
Interior Wood Doors	8	0	8	Negative
Ceramic Tile	1	1	0	Positive
Exterior Foundation	1	0	1	Negative
Wainscoat Walls	2	1	1	Positive
Stair Runs and Riser	3	1	2	Positive
